PHOTO REPORT

INSTALLING OF Ø400mm STEEL PIPE USING GRUNDORAM, GIGANT, PIPE PUSHING METHOD

- Client** : Brunei Shell Petroleum
(Zainal H.M. Daud Sdn Bhd)
- Country** : Brunei, Seria (F13 – G13)
- Equipment Used** : GRUNDORAM type Gigant Hammer
Fitted with upsized Ram Cone
- Ramming Distance** : 32m
- Pipe installed** : Ø400mm Steel Pipe
- Ground Condition** : Sandy with High Water Table
- Ramming Commencement Date** : 16th February 2006
- Ramming Completion Date** : 17th February 2006

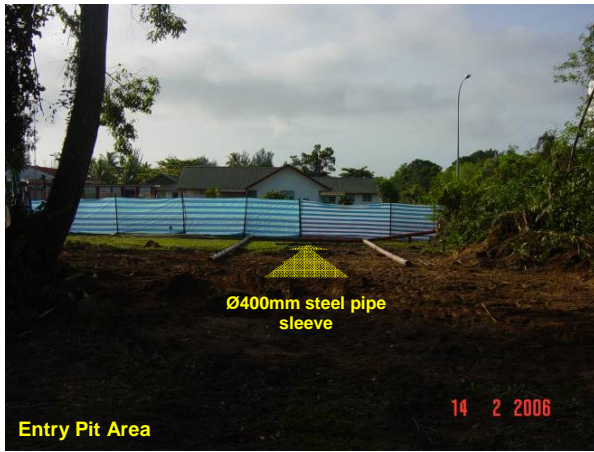
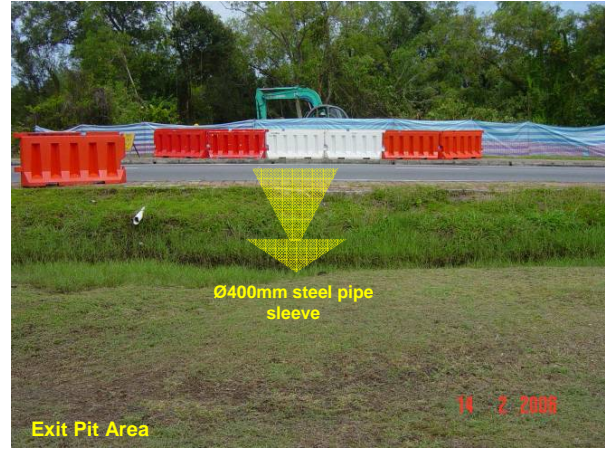
Photo 1 & 2: Installation of a Ø400mm steel pipe sleeve under a busy road (Jalan Tengah) in Brunei, Seria covering a distance of 32m.

Trenchless method was used as traffic is very busy because this is the only road connecting Seria to another town, Kuala Belait. In addition, BSP HQ is near the junction and traffic is very heavy during peak hours. There is also a fire station nearby and there is no alternative route for the fire station to use.

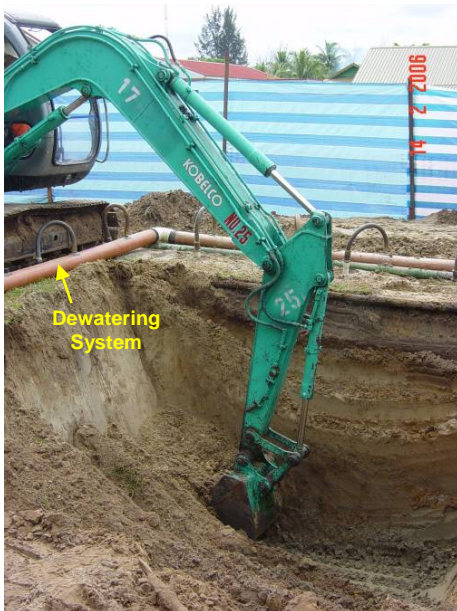
Photo 3: A view of the excavation being carried out.

The depth is 2.8m. Dewatering System had to be used as the soil condition in this area is very sandy with high water table.

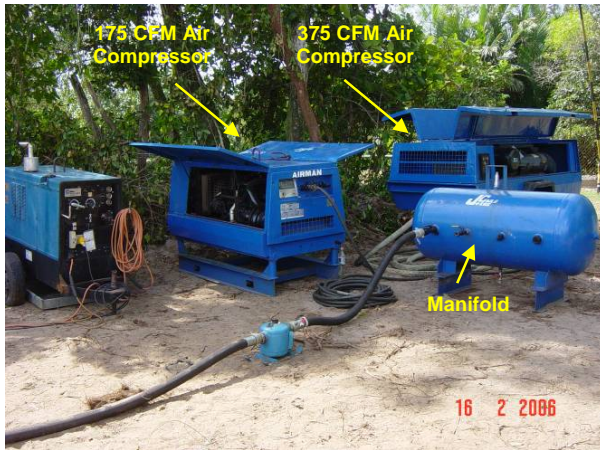
Photo 7: One 375CFM air compressor was combined with one 175CFM air compressor using a manifold to drive the Grundoram Gigant Hammer.

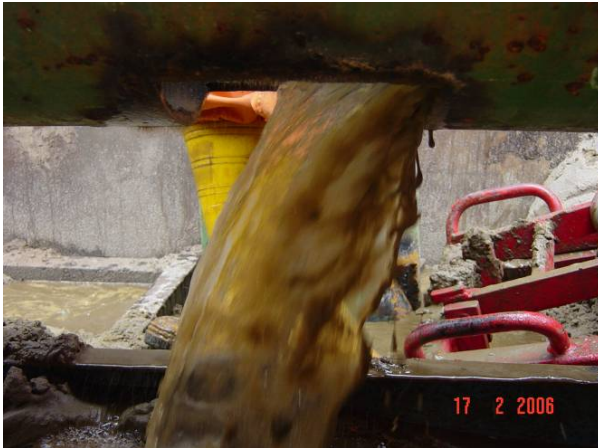
Photo 12: Water, together with sand in being washed out through the bottom hole on the steel pipe.

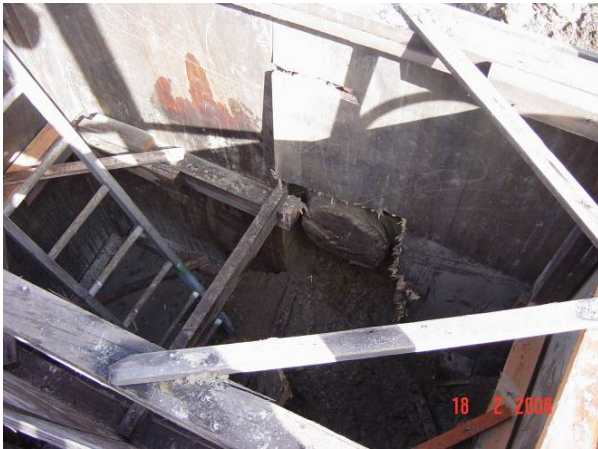
Photo 13: A view of the steel pipe emerging from the exit pit.

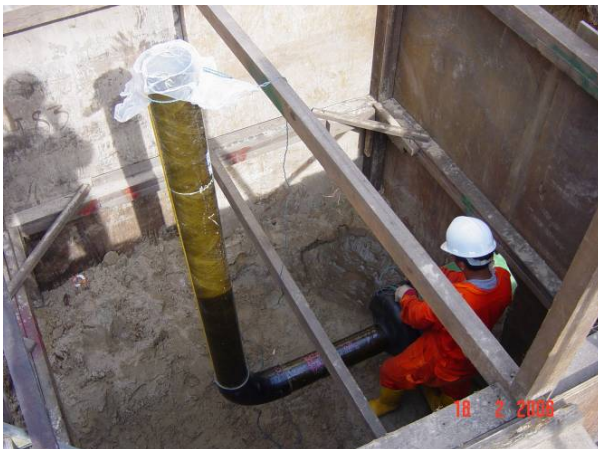
Photo 14: A view of the GRE pipe successfully inserted through the steel pipe.
