PHOTO REPORT

on the GRUNDOBURST 800G

Client: *Public Utilities Board, Sewerage Department,
Singapore*

Location: *Japanese Gardens, Singapore*

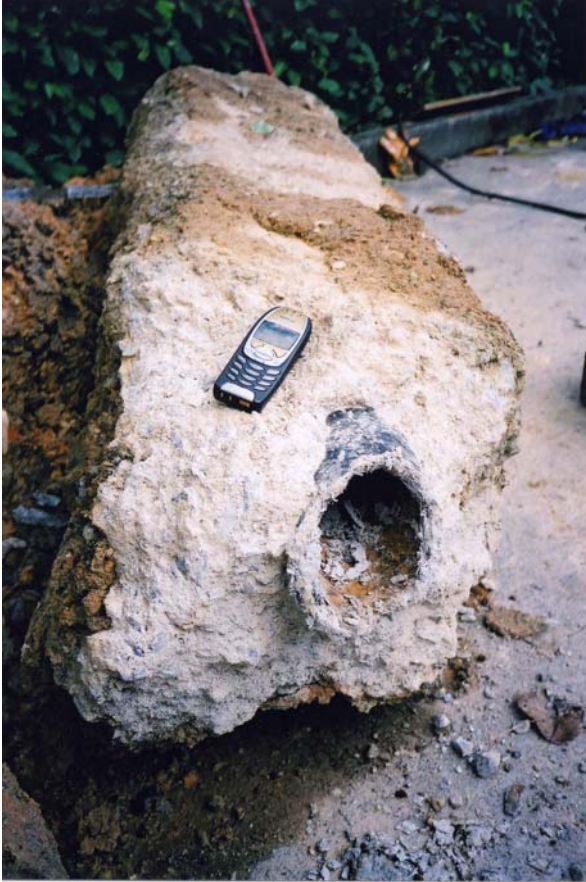
PHOTO 4 – Shows the amount of concrete placed around the 4" asbestos pipe to be burst.

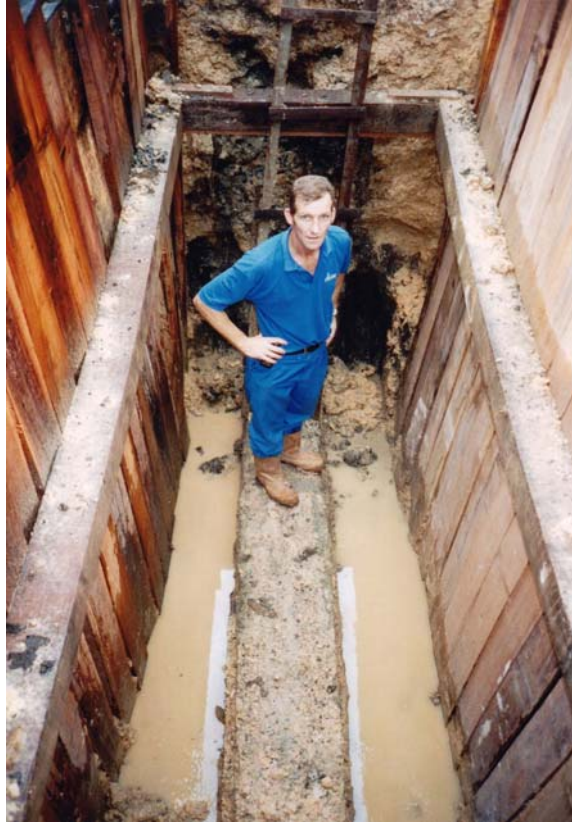
PHOTO 5 – In places the concrete measured 500mm x 500mm square.

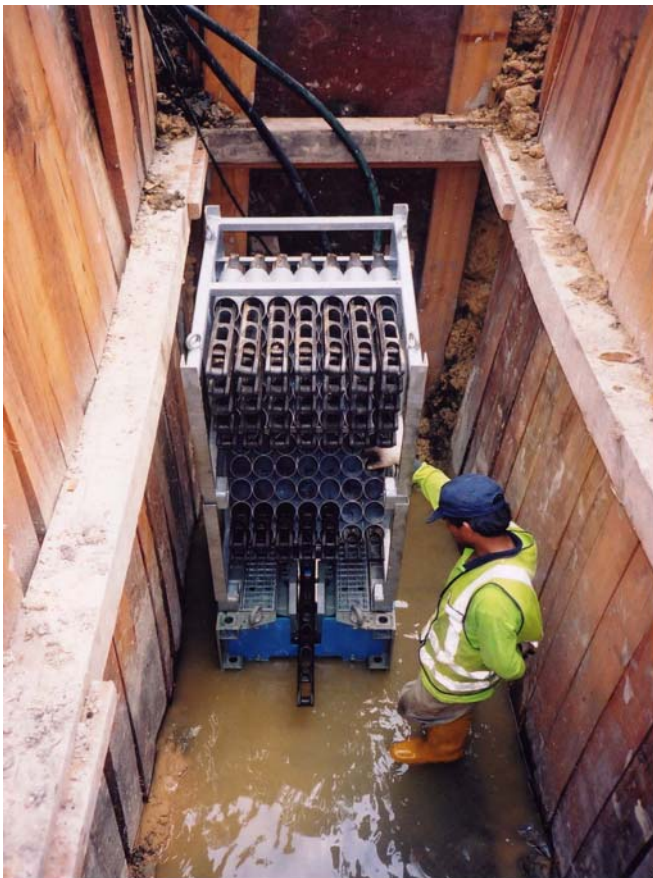
PHOTO 6: Shows the GRUNDOBURST 800G set up in the start trench where the patented Quicklock rods are pushed through the existing 4" AC pipe to be burst.

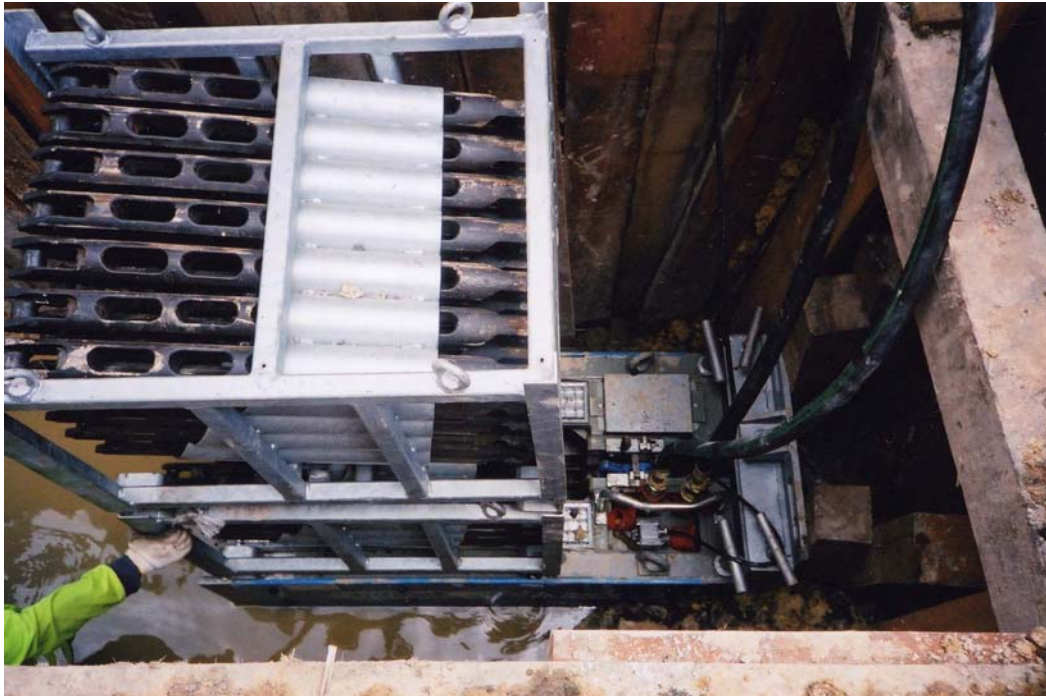
PHOTO 7: Note the unique rod storage boxes positioned on top of the GRUNDOBURST 800G.
Each rod storage box houses 35 off 0.7 metre rods.

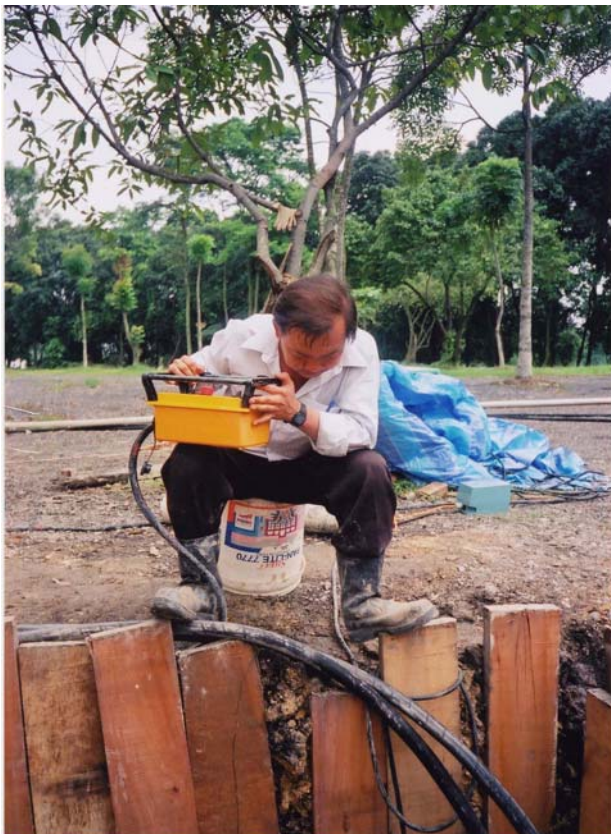
PHOTO 8:

All rig functions are via this remote control or foot control pendant.

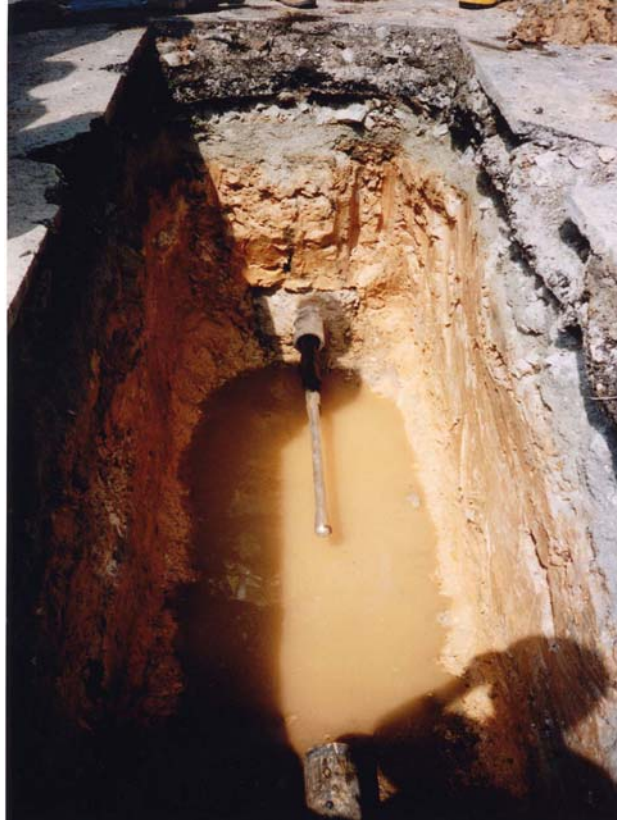
PHOTO 9: Shows the guide rod arriving in the exit trench after only 1 hour and 40 minutes of operation.

This time also included changing the rod storage boxes on 3 separate occasions.

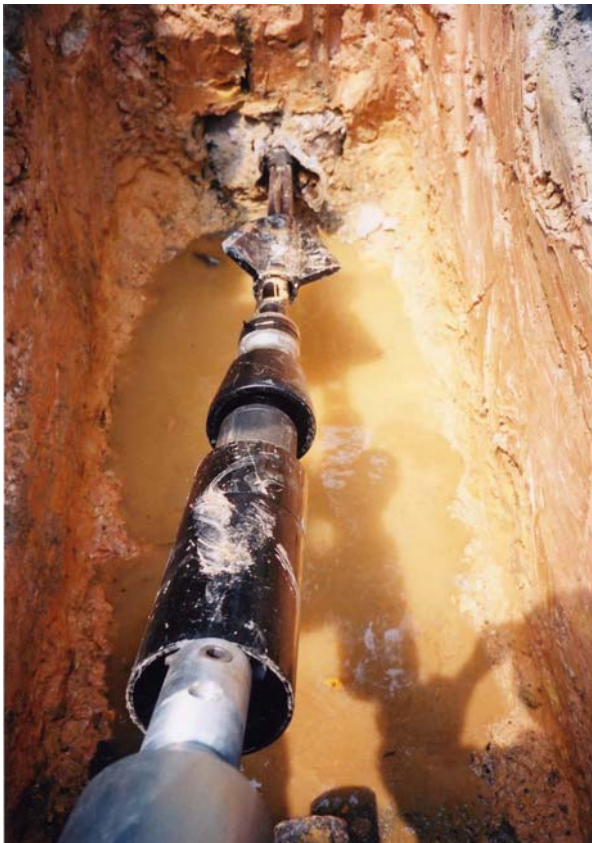
PHOTO 10: After removing the guide rod, we connected the various tooling required to burst the 4" asbestos pipe with the concrete surround.

Note: At the request of the PUB an inline load cell was fitted to ensure we did not exceed the yield strength of the 125mm pipe which was approximately 3.2 tonnes.

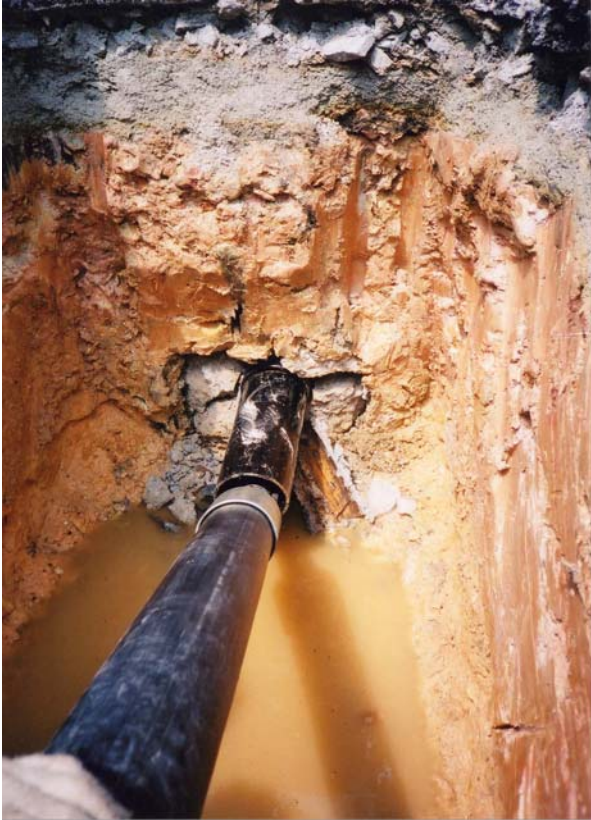
PHOTO 11: Shows the expander about to enter the bore after the bursting head has split the concrete.

Note the 125mm MDPE pipe directly behind the expander. Maximum tonnage required on pull back was approximately 10 tonnes which is only 12.5% of the machine's capacity.

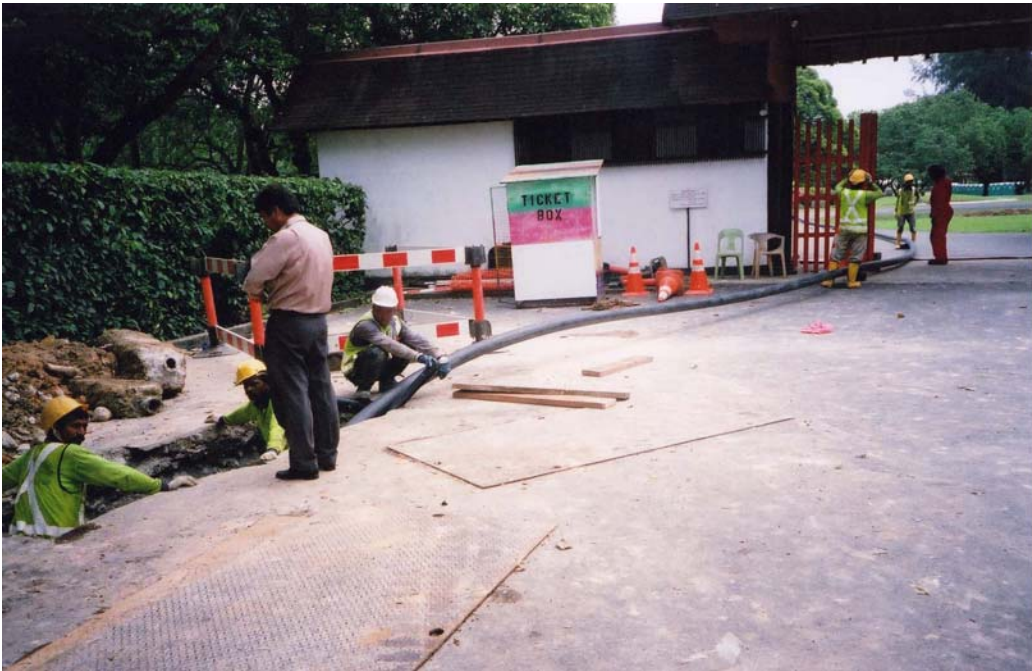
PHOTO 12 – Shows the 125mm PE pipe laid out during The bursting operation. Time taken to complete the bursting operation was 2 hours 10 minutes

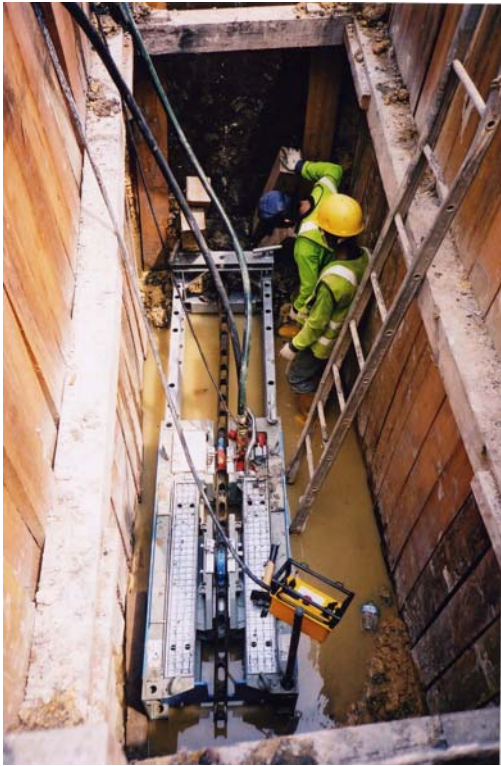
PHOTO 13 above – Shows the GRUNDOBURST 800G extended to allow the retrieval of the tooling and the 125mm PE pipe following the bursting operation

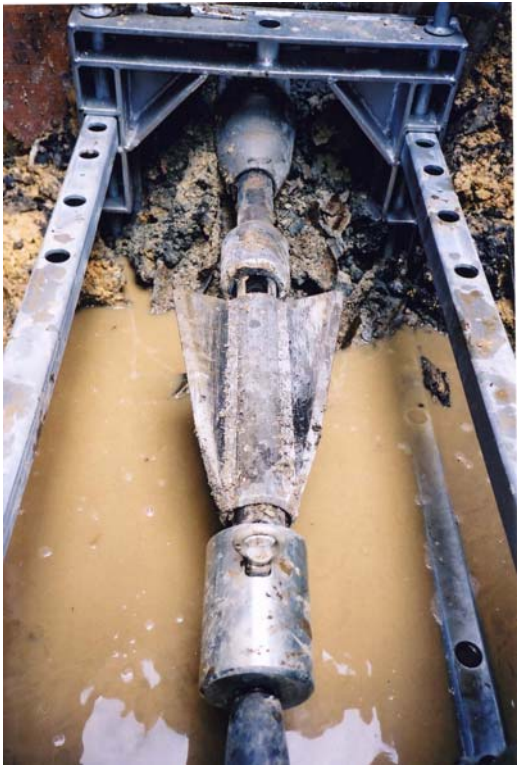
PHOTO 14 above – Shows the tooling arriving in the trench.

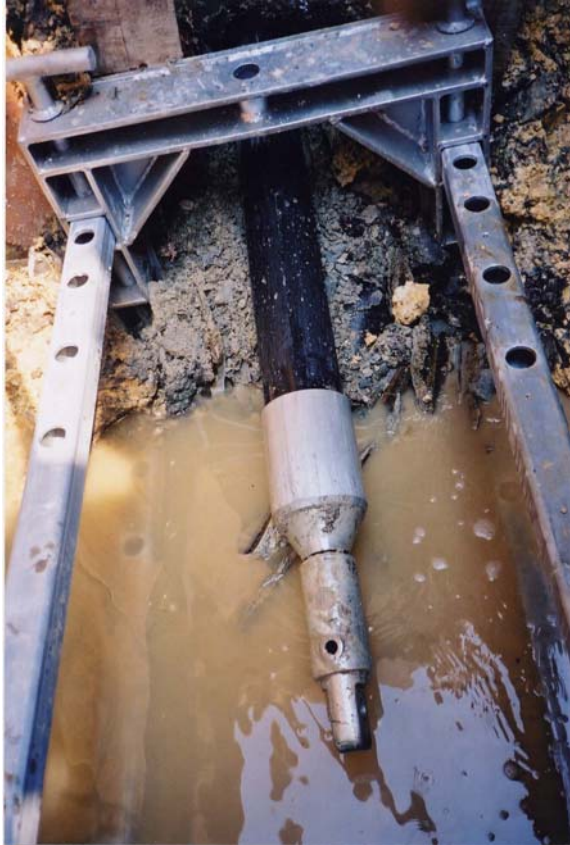
PHOTO 15 – Shows the towing head and 125mm PE pipe pulled into the launch pit in readiness to be connected to the existing sewer.

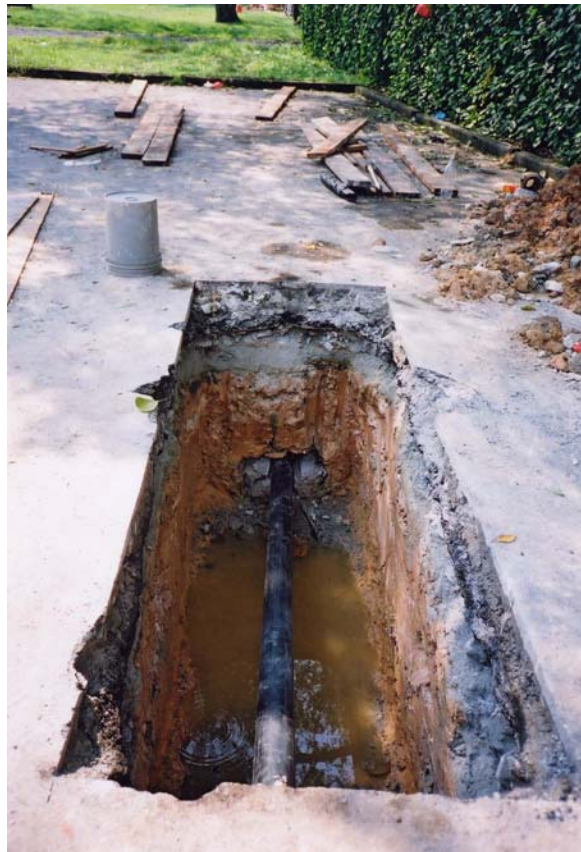
PHOTO 16 – View of 125mm PE pipe in the receive pit where a temporary connection to the existing sewer will be made until the next day's burst.
