NIBCO Solutions Takes on Ductile Iron Bursting in Illinois

NUCA contractor NIBCO Construction Concepts, LLC, Joliet, Ill., recently completed a difficult static pipe bursting project in Peru, Ill. The project was completed for petrochemical company Huntsman Corporation and included replacing an aging fire protection system. The project, however, could not be completed through traditional open cut construction methods. According to NIBCO Vice President Jay Boban, NIBCO was chosen to perform a trenchless rehabilitation and replacement option.

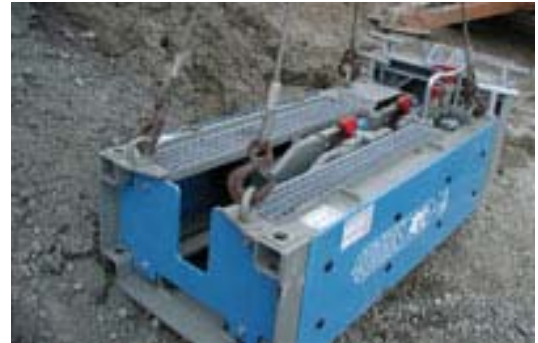
The NIBCO crew used a Grundoburst static bursting system like the one pictured here.

NIBCO crews used the Grundoburst 1000G static pipe bursting system from Associate NUCA member TT Technologies, Aurora, Ill.

The Grundoburst 1000G hydraulically operated static bursting system is one of six Grundoburst models. The 1000G is designed for bursting fractureable pipe, as well as ductile iron and steel pipe up to 20-inches in diameter. According to TT Technologies Pipe Bursting Specialist Ben Cocogliato, several of the system’s features make bursting steel, as well as ductile iron, possible. He said, “During the static bursting process, a special bladed roller cutting head is pulled through the existing line by the bursting unit. As the bladed rollers are pulled through, they split the host pipe. An expander attached to the rollers forces the fragmented pipe into the surrounding soil while simultaneously pulling in the new pipe.”
